# Analysis of TFT Array Erosion Defect

LI Li, QIN Wei, XUE Jian-she, PENG Zhi-long

(Beijing BOE Optoelectronics Technology Co. Ltd., Beijing 100176, China, E-mail: uniuqelily@126.com)

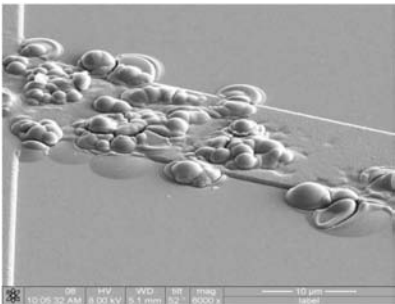
Fig. 2 SEM picture of the defect surface

From the SEM picture of the defect surface in Fig. 2, it can be seen that these defects are some continuous protuberance. And their shape looks like lots of frog eggs.

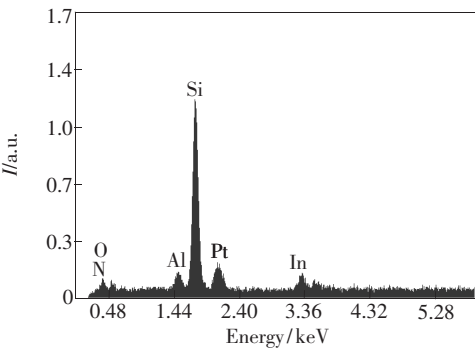
Fig. 3 EDS spectrum of defect surface

Fig. 3 is the EDS spectrum of defect surface. It can be seen that the defect surface mainly contains the elements such as N,O,Al,Si,Pt,In,

etc. And these normal elements come from the gate layer, G-SiN<sub>x</sub> gate insulator layer, PVX layer, ITO layer and Pt layer.

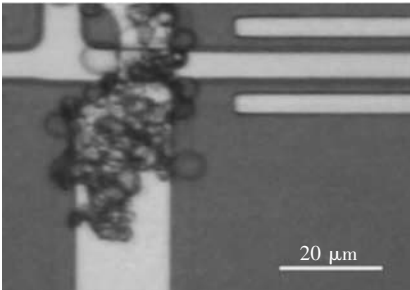
Fig. 1 Microscope picture of the defect area (×100)

cleaning, the TFT array substrate was observed under the microscope. The array defect was confirmed to be frog egg, and the microscope picture was shown as Fig. 1

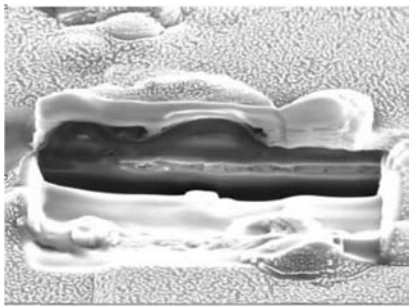
Fig. 4 FIB picture of defect section

The continuous protuberance was split by FIB with the 52° view angle. The picture was shown as Fig. 4. There were too much small holes at the section picture. And there were obvious protuberance on the gate layer. GiN<sub>x</sub> layer have the same thickness on the protuberance as normal gate layer. There are the same conclusion with above.

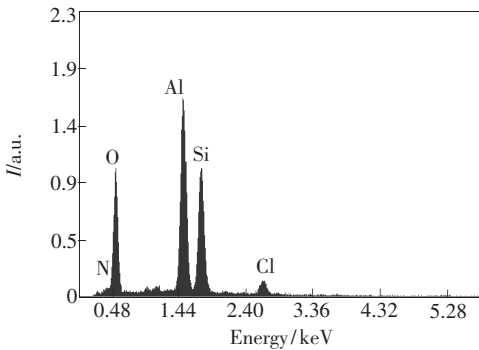
Fig. 5 EDS spectrum of defect section

From the EDS spectrum of the defect section in Fig. 5, it can be seen that this protuberance is made of O, Al, Si, Cl, etc. element. Cl element is not the ingredient of normal TFT-LCD. But during the array process, the Cl element was only used to dry etch gas as Cl<sub>2</sub> and wet etchant as HCl or other acid.

Gate line was made of two layers: Mo and AlNd. AlNd is so active that it is more easily to be eroded by some active gas or liquid. So the hole appeared at the gate metal layer.

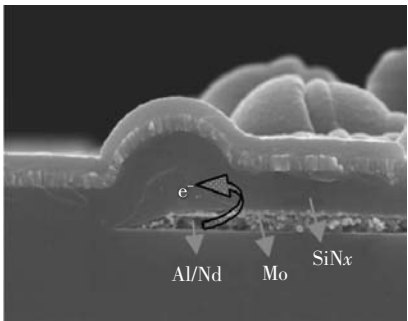
Fig. 6 SEM picture of defect section

The defect section was observed clearly after dipping for a while in BOE (Buffered Oxide Etchant)solution. From the SEM picture in Fig. 6, it can be seen that the layer distribution: gate metal layer, SiN<sub>x</sub> gate insulator layer, active layer, source/drain metal layer and PVX SiN<sub>x</sub> layer stacked. The thickness of all layers is normally except that of the gate layer. There are so many holes in the first gate layer. And there is an unknown something existing between the gate layer and GiN<sub>x</sub> nonmetal layer. So this defect occurred before the deposition of GiN<sub>x</sub> non-metal layer. When these metal layer surface is permeated with the acid gas, the different metal has different electric voltage on their surface. As anode, active Al and Nd lost their electrons in the electrochemistry reaction.

When the electrochemical reaction was starting from the anode (Al/Nd), metal Al and Nd transformed to ion state, and interfused to electrolyte or other layer. Then the hole was produced. With the process ongoing, the corroded area spreaded. At last, the Al/Nd/Si/Cl/O compound with very low conductivity was produced. The gate line was influenced by the compounds and the holes. The turn-on voltage is deficient, and resulted in the resistant of gate line becoming higher and higher. At the normal white mode of TFT-LCD, it shows that the bright line

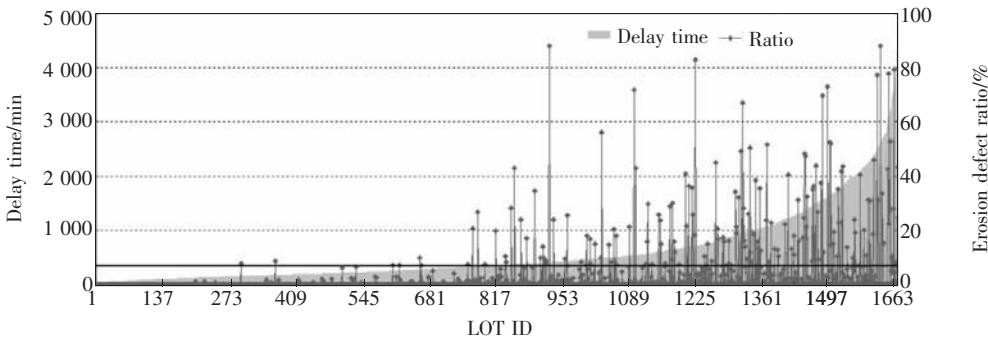
Fig. 7 Relation between erosion defect ratio and delay time

Lastly, the relevant relation between the defect ratio and delay time which is after Gate Etch process and before Multi-Deposition process was obtained by statistic software BO (Business Object), as in Fig. 7. The defect decreases as delay time goes down, and especially the incidence is very low when delay time is smaller than 300 min. In practical, by means of controlling the delay time less than 300 min, this erosion defect incidence can be very low. As the same time, it is an emergency measure to increase the speed of cycle wind in the product line if this defect appears. But the exactly leakage point have not been found.

analysis and statistic software BO (Business Object), CIM (Computer Integrated Manufacturing), it can be concluded that erosion happened between Gate Etch process and Multi-Deposition process. And by tracking the product process, the leakage position can be confirmed. The reason is HCl enchants leakage; By statistic software, the defect incidence decreases as delay time going down between Gate Etch process and Multi-Deposition process. So when the defect occurred massively, controlling the delay time below 300 min will minimize the loss.
