## 阵列基板铜工艺不良研究

## Cu defects in array process

(Beijing BOE Display Technology Co., Ltd., Beijing 100176, China)

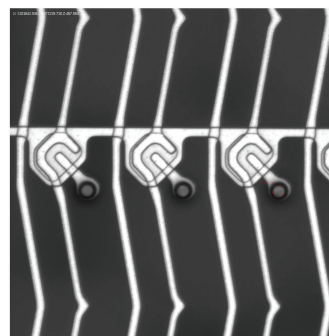
Fig. 2 is taken on ORG FICD (Final Inspection Critical Dimension) in AA (Active Area) zone. It can be seen that the pixel hole is very

Fig.2 Defect of pixel hole in AA zone

black. This color is abnormal because the inside of the hole is copper and it should be as bright white as the SD line under the same vision.

The three main steps of the ORG layer are PVX1 DEP, ORG mask and PVX1 etch (also called ORG etch). The difference from other layers is that the organic film here acts as PR (Photoresist), but remains in the array structure without being removed. ORG FICD actually reflects the form after PVX1 etch. It is well known that CuO is black. So the blackening of the hole indicates that the Cu surface inside has been oxidized. In order to clarify the step of Cu oxidation, the pictures obtained before PVX1 deposition and after ORG mask, respectively. Obviously, it can be seen that the position of the base of the hole in Fig. 5 (a) is the same as the SD line. In Fig. 5 (b), all positions except the hole are covered with a layer of PVX1 and ORG, both of which are transparent substances. Therefore, the color of all the locations where the metal is present is the same in DICD (Development Inspection Critical Dimension). Fig. 2 clearly shows that the holes are blackened, illustrating that the defect occurs in PVX1 etch.

In order to improve this defect, the usual method is to add a gas treatment process.  $\text{H}_2$  is a reducing gas commonly used in factories. After PVX1 etch is completed, array glass is placed in  $\text{H}_2$  plasma (55 500 mL/min) atmosphere for 40 s and then CD is tested. By contrast, it can be seen from Fig. 7 that the hole appears bright white again just like the metal line. Furthermore, the yield of array glass after  $\text{H}_2$  treatment increased by 36%. All these show that  $\text{H}_2$  plasma is effective for reducing CuO and the treatment can improve the contact resistance.

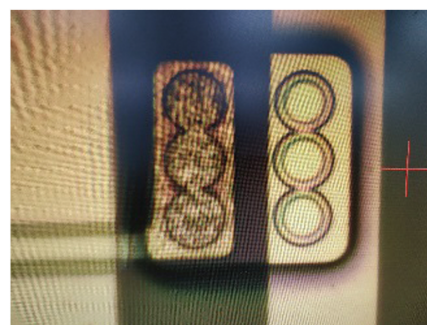
As shown in Fig. 3, GOA (Gate on Array) hole is taken by optical microscope after the array substrate is fabricated. Black stain and abnormal color can be observed in the left SD hole while the gate hole on the right is clean.

Fig.3 Defect of SD hole in GOA zone

Attention should be paid to the high temperature environment of Cu when ITO layer is made after SD layer in array process sequence. To solve this problem, we can skip anneal step in 1ITO etch and wait for 2ITO anneal as compensation. In 2ITO anneal, 1ITO or 2ITO covers all the exposed SD Cu, so the oxidation phenomenon caused by anneal will not happen again. On the other hand, when changing design

of 1ITO mask to make all exposed SD Cu covered with PR, the remained 1ITO can protect Cu from oxidation.

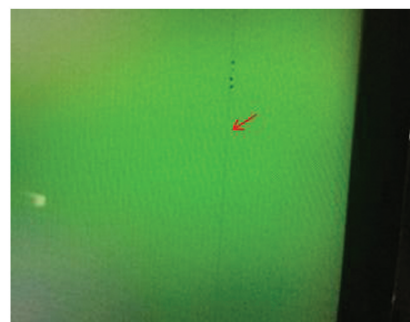
From Fig. 4, we can see that vertical black line appears in monochromatic green picture when the module is lighted. The incidence of this

Fig.4 Vertical line Mura

defect is about 20%, and its distribution on array glass (2.2 m×2.5 m) is irregular.

VIA etch is dry etch performed using plasma formed of  $\text{SF}_6$  and  $\text{O}_2$ . When the  $\text{O}_2$  content of VIA etch is changed from 62% to 41%, the incidence of vertical line Mura can be reduced to 0%. It can be seen that when the oxygen content in gas of VIA etch is too high, the oxidation reaction of Cu causes the abnormal contact between 2ITO and Cu at the connection hole. The oxidation leads to the increase of data line RC delay and eventually the occurrence of vertical line Mura.

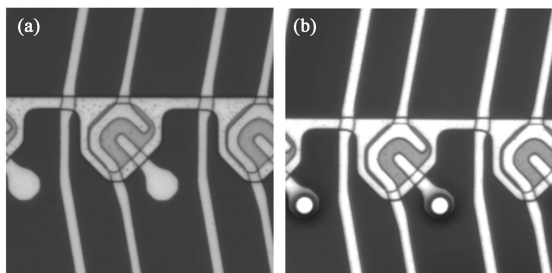
Fig.5 Image of TFT in AA. (a) FICD before PVX1 deposition; (b) DICD after ORG mask.

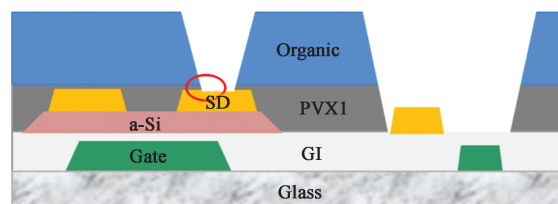
Fig.6 Diagram of CuO protective film

role of  $\text{O}_2$  is to promote the dissociation of  $\text{F}^*$ , from  $\text{SF}_6$  so as to increase the etching rate. In the second step, the gas flow ratio of  $\text{SF}_6$  and  $\text{O}_2$  is changed to 1 : 30. Undercuts of ORG and PVX (as shown in the Fig. 6) are avoided through the reaction between  $\text{O}_2$  and organic film. Unfortunately, during this process, the high content of  $\text{O}_2$  will react with the exposed Cu, resulting in a darker color at the hole shown in the equation (2):

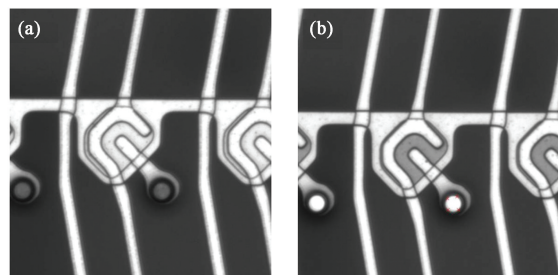
Fig.7 Image of TFT in AA. (a) FICD after PVX1 etch; (b) FICD after  $\text{H}_2$  treatment.

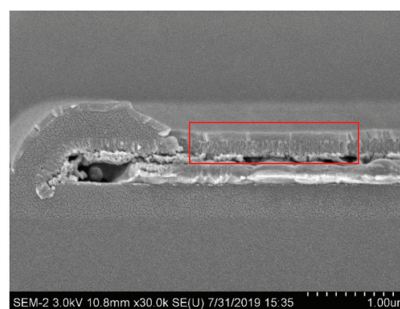
In order to observe the abnormality of GOA hole, the cross-sectional picture of this area was obtained by SEM (Scanning Electron Microscope) in Fig.8. There is a thick layer of corrosive substance between 2ITO and SD, presumed that SD Cu was reacted. Fig. 9 and Fig. 10 is the picture before 1ITO DEP and after 1ITO etch respectively. According to the pictures, after making 1ITO layer, the surface of SD Cu in GOA area is tightly covered by a layer of corrosion products. While gate Cu remains unchanged because it is covered by GI (Gate Insulator) layer. It can be determined by comparison that the steps of abnormal occurrence is 1ITO layer, which includes 1ITO DEP, 1ITO mask and 1ITO etch. Experience tells us that 1ITO DEP and mask will not cause the deterioration of Cu thin film. Therefore 1ITO etch is the most doubtful step.

Fig.8 Image of section of the GOA SD hole

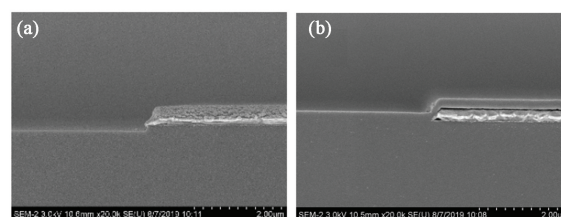
Fig.9 Image of Cu before 1ITO DEP; (a) SD Cu; (b) Gate Cu.

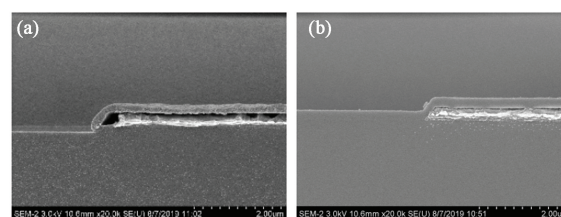
Fig.10 Image of Cu after 1ITO etch. (a) SD Cu; (b) Gate Cu.

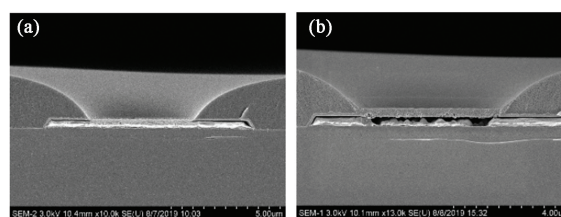
1ITO etch includes wet etch and anneal which can convert ITO into a polycrystalline state with low electrical resistance and high transmission rate, so the sample is validated by these two processes separately after 1ITO mask<sup>[5]</sup>. The results show that no abnormality is found in the samples after wet etch. Samples placed in oven at 230 °C for 30 min are shown in Fig. 11(b). There exists a layer of corrosives similar to Fig. 8. This surely serves to illustrate most clearly that the exposed SD Cu will be oxidized by high temperature heating in CDA (Clean dry Air) in anneal process. Thus resulting in the open of GOA circuit.

Fig.11 Image of SD Cu in active area. (a) After 1ITO wet etch; (b) After 1ITO anneal.

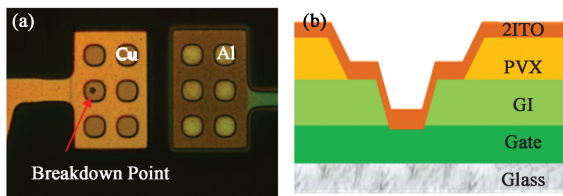
ity of picture<sup>[6]</sup>. In the case of vertical line Mura, gate uses Cu and SD uses Al. The hole in GOA can make the electrical conduction between peripheral circuit and data line of the display area. At the beginning, laser is used to break down the Cu hole to make the electrical conduction there as shown in Fig.12(a). The results show that the breakdown of Cu through gate layer makes the Cu/2ITO lap and Mura disappear. While the crossover hole on SD Al is broken down, the defect remains unchanged. Therefore, it can be judged that the hole on the surface of gate layer is abnormal.

Fig.12 (a) Breakdown of hole by laser in peripheral circuit; (b) Schematic diagram of the section of the gate hole.

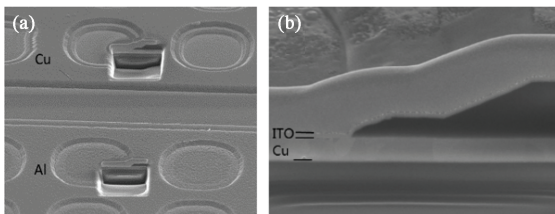
Then, the abnormal gate Cu holes are tested by focused ion beam microscopy (FIB). As shown in Fig.13, there is no abnormal 2ITO on the surface of the hole and 2ITO lap at the climbing position with right slope angle. So 2ITO layer is conducting normally. More importantly, the slope angle of the hole is also gentle with no undercut exist. Therefore, it is suspected that the surface corrosion of Cu leads to circuit breakage.

Fig.13 FIB test result of hole. (a) Top view; (b) Cross section of abnormal Cu.

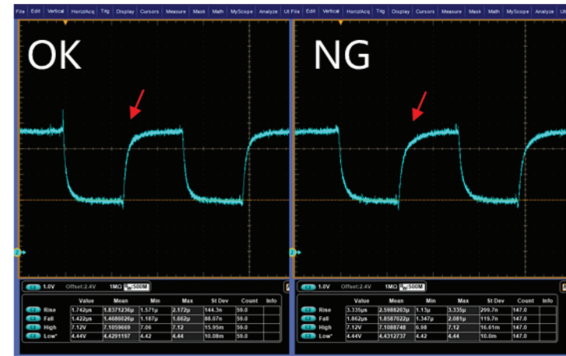
Fig.14 Electrical waveform test of data line

the OK sample from Fig. 14, the NG (Not Good) sample has a delay of  $0.679 \mu\text{s}$  at low voltage and  $0.39 \mu\text{s}$  at high voltage in the rise region of waveform. When the fall part of the waveform is compared with the OK sample, the delay of NG sample is  $0.141 \mu\text{s}$  at low voltage and  $0.137 \mu\text{s}$  at high voltage. In Z-inversion display mode, the data line of monochrome picture fluctuates in each frame<sup>[7]</sup>. Poor contact of data line through the gate holes can cause electric waveform delay in each frame and affect the brightness of the picture. So the vertical line Mura appears in this situation.
